**The Corporation of the District of North Vancouver**  
**REPORT TO COUNCIL**

**AUTHOR:** Brian Bydwell - Chief Building Inspector

**SUBJECT:** 1593 Lennox Street

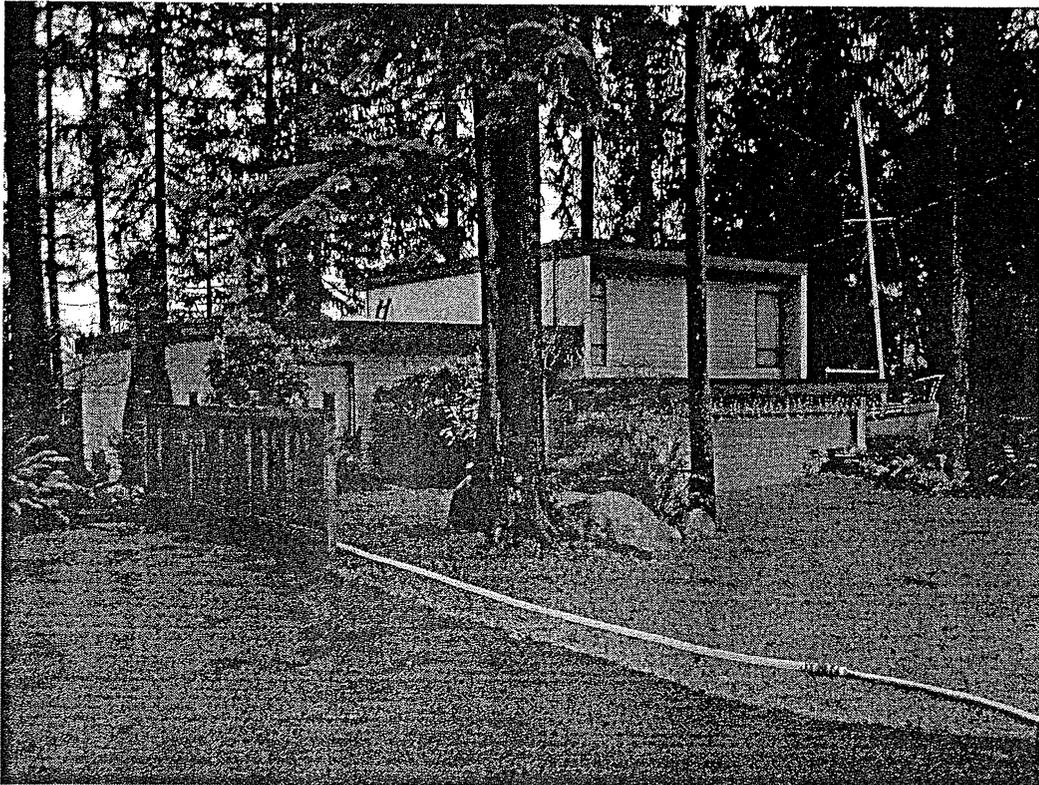
Photograph 1

The subject property is located at the north end of Lennox Street on the west side of the street (see Photograph 1). Natural grade slopes down dramatically from the rear (west side) of the house. A concrete retaining wall located 9 feet from the north side of the house extends 22 feet to the west from the northwest corner of the house. Foundations step down from 2 feet to 10 feet below the top of the wall at the northwest corner. The retaining wall extends 59 feet to the south to 5 feet south of the house. At the southwest corner, the 4 foot high concrete block retaining wall is 28 feet west of the rear of the house. The wall returns east and extends 5 feet from the corner. Downhill grade at the southwest corner is 12 feet below the top of the concrete block wall with grade below retained by timber cribbing extending 10 feet below the concrete footing at the corner. Grade slopes up to the level of the crawl space grade at the back of the house. A wood picket fence extends four feet above the top of the wall supported by 4x4 posts bolted to the rear yard side of the wall.

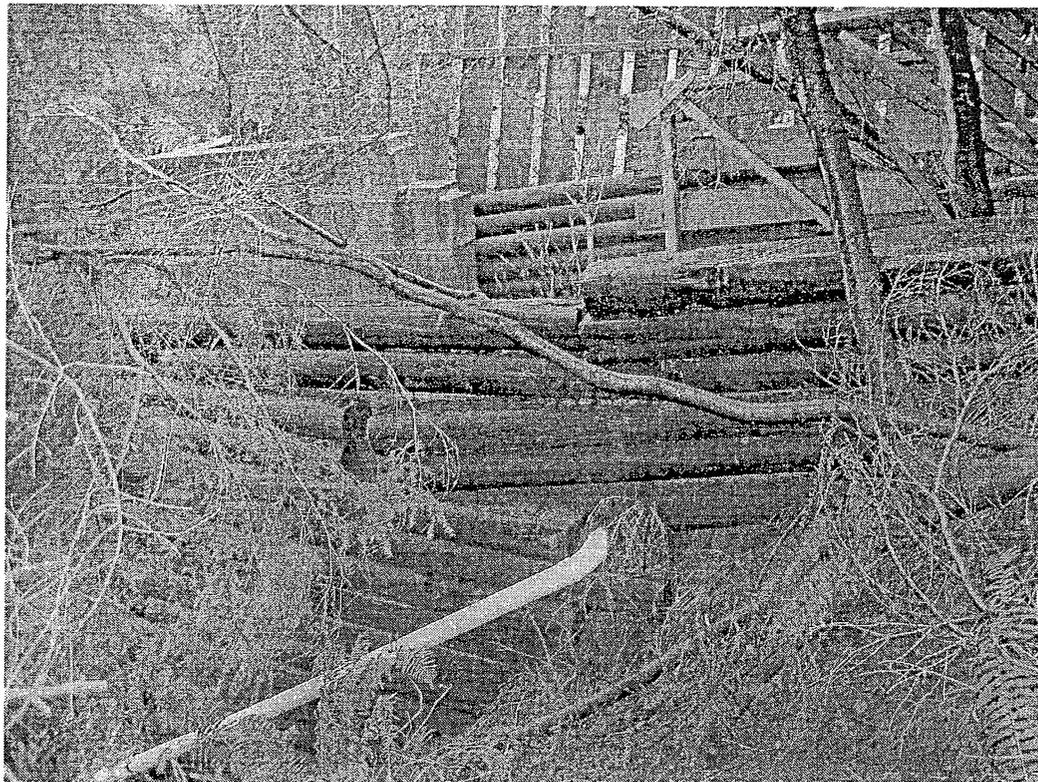
Photograph 4

The downhill exposed wall faces show evidence of significant repointing undertaken since the original construction. Cracks appear to be old and pre-exist the current significant rain fall period by a number of years. The writer observed no evidence of significant recent movement in the concrete block wall structure. The timber cribbing at the southwest corner of the rear yard is old and deteriorated and evidence of significant movement, likely recent, was observed (see Photograph 4).
