## **BGC ENGINEERING INC.**

June 22, 2005

Project No. 0405-001-02

### **RE: SLOPE STABILITY ANALYSES AT 2157 AND 2191 BERKLEY AVENUE**

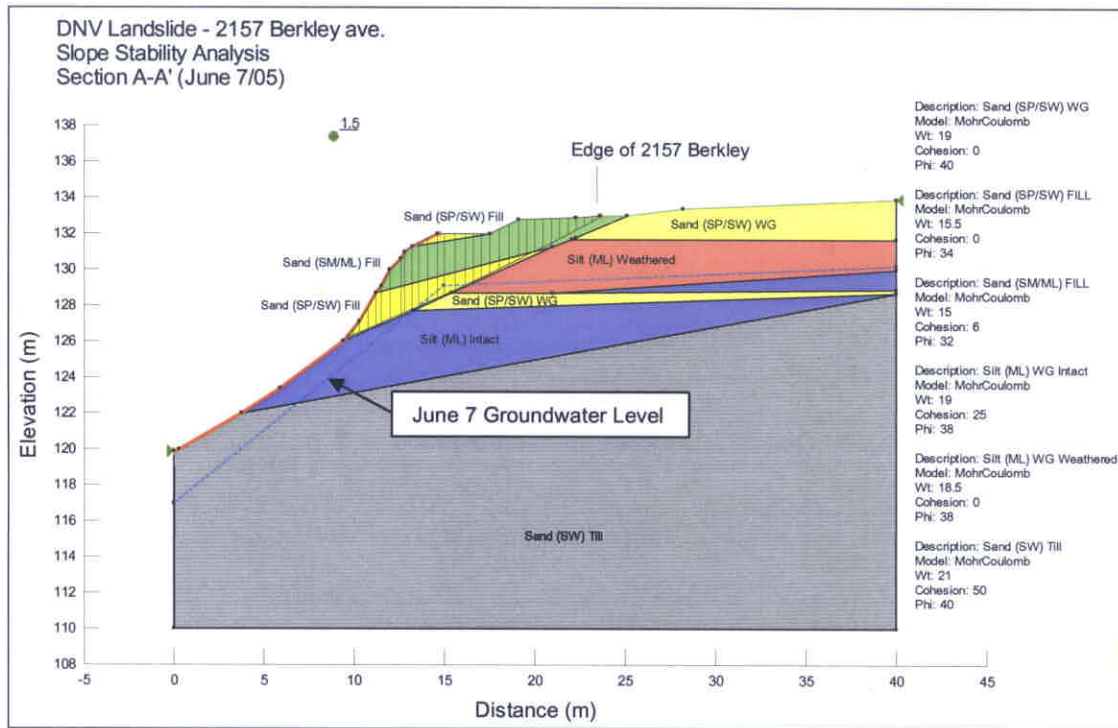
**Figure 1. Slope Stability Analysis for Section A-A' (2157 Berkley Avenue)**

Cross Section	Property	June 7, 2005 Groundwater Level	March 21, 2005 Groundwater Level	March 21, 2005 Groundwater Level + 0.5 m
A-A'	2157 Berkley	1.5	1.5	1.3
C-C'	2191 Berkley	1.5	1.5	1.2

It is important to note that the factors of safety presented in Table 1 and the slip surface geometries shown in Figures 1 and 2 do not represent critical slip surfaces or minimum factors of safety near the edge of the natural escarpment and headscarp of the January 19, 2005 landslide. Shallower slip surfaces located closer to the edges of these scarps have lower factors of safety than those presented in Table 1. For example, the factor of safety on the critical slip surface for cross section A-A' under March 21, 2005 groundwater levels is about 1.1, compared to a factor of safety of 1.5 for a slip surface that is forced to pass deeper into the slope and intersect the house at 2157 Berkley. Similarly, the critical slip surface for cross section C-C' has a factor of safety of about 1.0 under March 21 groundwater levels, while a deeper slip surface intersecting the house has a factor of safety of 1.5. This issue of personal safety for any person standing at or near the edge of these scarps when a shallow landslide occurs is beyond the BGC scope of work reported here.

- a) provided the groundwater levels in none of the site piezometers exceed their March 21, 2005 values, the residences at 2157, and 2191 Berkley may be occupied on a temporary basis; and,
- b) if any of the groundwater levels exceed those observed on March 21, 2005, a visual inspection, review of all piezometer data, and assessment of predicted short-term rainfall should be promptly conducted, possibly leading to the re-evacuation of 2157 and/or 2191 Berkley.
