BGC ENGINEERING INC.

June 22, 2005

Project No. 0405-001-02

RE: SLOPE STABILITY ANALYSES AT 2175 BERKLEY AVENUE

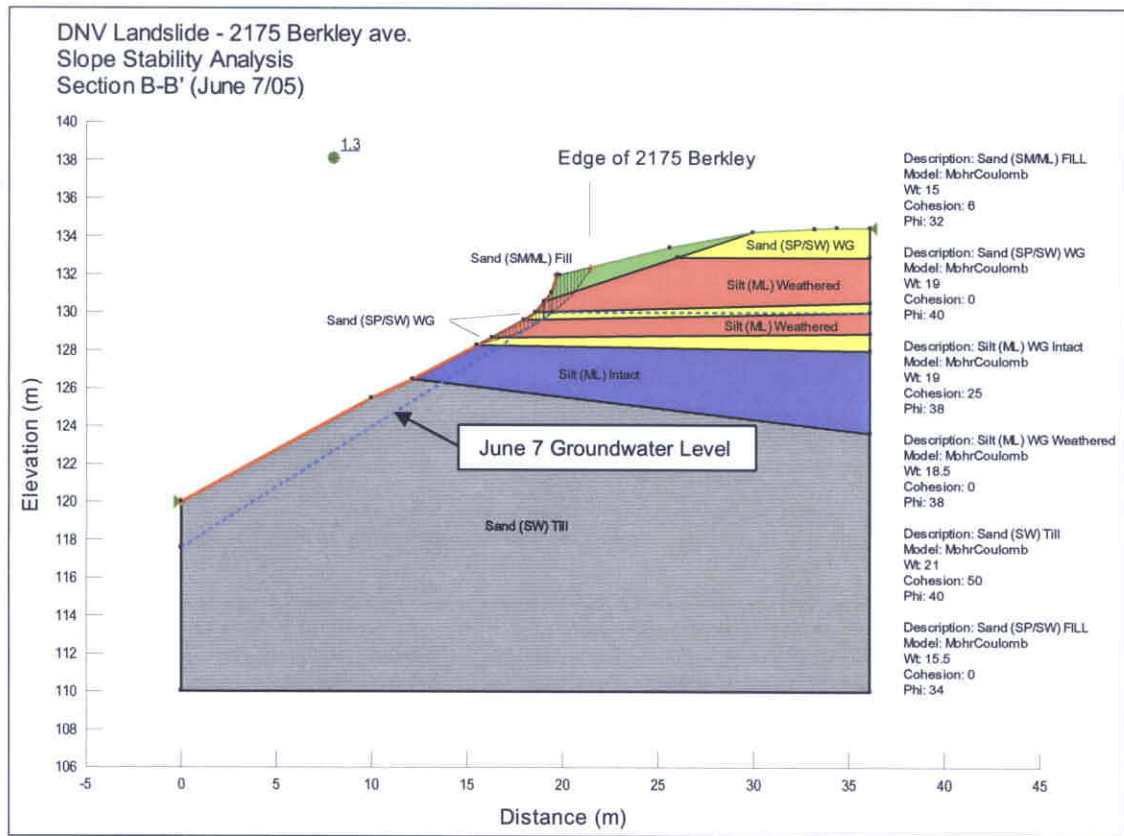
Figure 1 - Slope Stability Analysis for Section B-B' (2175 Berkley Avenue)

A stratigraphic cross section through the property was developed for the purpose of slope stability modelling (Figure 1).

- groundwater levels measured in the piezometers matched observations of seepage around the headscarp of the landslide; and,
- the factor of safety under the highest groundwater conditions measured by the piezometers following the landslide exceeded 1.0 near the edge of the escarpment for the cross section shown in Figure 1.

Once the slope stability model was calibrated, additional analyses were undertaken to evaluate the factor of safety against failure along hypothetical slip surfaces that were forced to intersect the edge of the house. Groundwater conditions measured on June 7, 2005 (the most recent data) and on March 21, 2005 (the highest groundwater conditions observed since piezometer installation) were used in the analyses. Additional analyses were carried out using groundwater conditions 0.5 m higher than observed on March 21. This level was selected arbitrarily so as to evaluate the sensitivity of the analyses to an elevated water table. Table 1 summarizes the results:

Cross Section	Property	June 7, 2005 Groundwater Level	March 21, 2005 Groundwater Level	March 21, 2005 Groundwater Level + 0.5 m
B-B'	2175 Berkley	1.3	1.2	<1.0

It is important to note that the factors of safety presented in Table 1 and the slip surface geometry shown in Figure 1 do not represent critical slip surfaces or minimum factors of safety near the edge of the headscarp of the January 19, 2005 landslide. Shallower slip surfaces located closer to the edge of the escarpment have lower factors of safety than those presented in Table 1. For example, the factor of safety on the critical slip surface in the back yard of 2175 Berkley under March 21, 2005 groundwater levels is about 1.0, compared to a factor of safety of 1.2 for a slip surface that is forced to pass deeper into the slope and intersect the house.

Standard geotechnical engineering practice requires permanent slopes be designed with a minimum factor of safety of 1.5. Factors of safety of 1.3 are sometimes accepted for slopes where the consequences of failure are low, or where a loss of strength during shearing is not anticipated. Neither of these conditions applies along the Berkley-Riverside Escarpment, thus BGC recommends adopting a factor of safety of 1.5 as the minimum acceptable level for house re-occupation.

Based on these guidelines and the results of the slope stability analyses reported in Table 1, BGC recommends that the residence at 2175 Berkley should remain unoccupied until such time as remedial measures are undertaken to raise the factor of safety above a value of 1.5. BGC's preliminary assessment, however, is that remediation to allow re-occupation of 2175 Berkley is unlikely to be practical when the cost-benefit of remediation is considered.
