BGC ENGINEERING INC.

Project No. 0405-001-02

RE: SLOPE STABILITY ANALYSES AT 2205 BERKLEY AVENUE

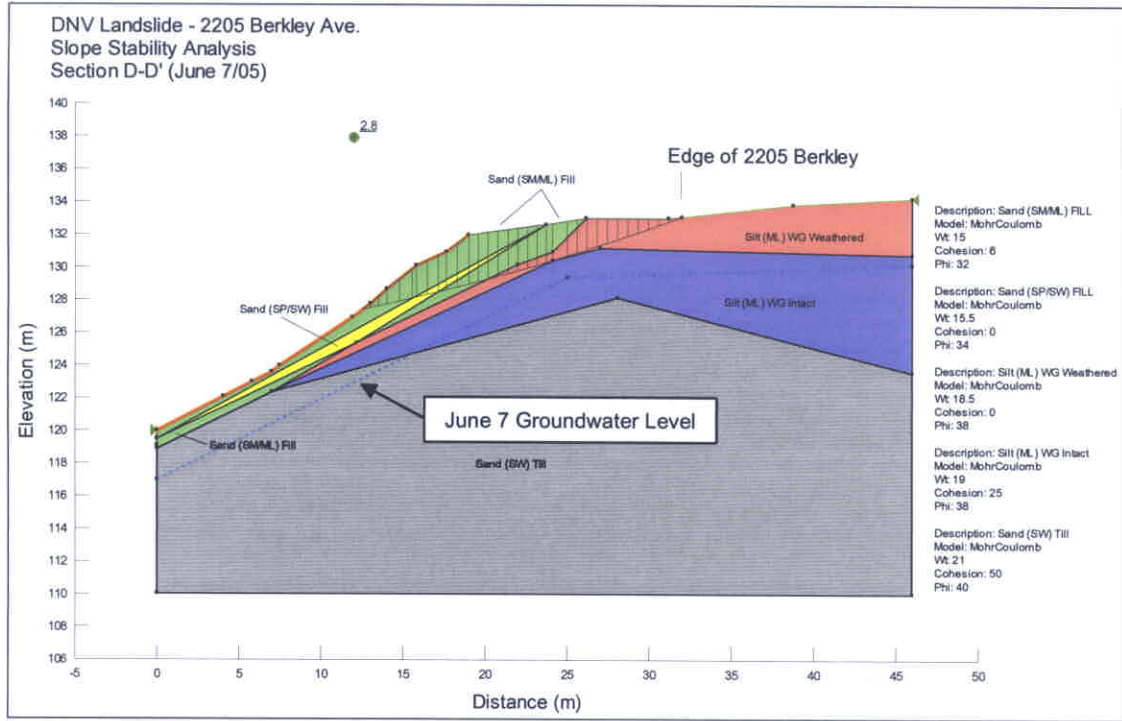
Figure 1. Slope Stability Analysis for Slides Impacting the House at 2205 Berkley Avenue

A stratigraphic cross section through the property was developed for the purpose of slope stability modelling (Figure 1).

Once the slope stability model was calibrated, additional analyses were undertaken to evaluate the factor of safety against failure along hypothetical slip surfaces that were forced to intersect the edge of the house on the subject property. Groundwater conditions measured on June 7, 2005 (the most recent data) and on March 21, 2005 (the highest groundwater conditions observed since piezometer installation) were used in the analyses. Additional analyses were carried out using groundwater conditions 0.5 m higher than observed on March 21. This level was selected arbitrarily so as to evaluate the sensitivity of the analyses to an elevated water table. Table 1 summarizes the results:

Cross Section	Property	June 7, 2005 Groundwater Level	March 21, 2005 Groundwater Level	March 21, 2005 Groundwater Level + 0.5 m
D-D'	2205 Berkley	2.8	2.7	2.6

It is important to note that the factors of safety presented in Table 1 and the slip surface geometries shown in Figure 1 do not represent critical slip surfaces or minimum factors of safety near the edge of the escarpment. Shallower slip surfaces located closer to the edge of the escarpment have lower factors of safety than those presented in Table 1. For example, the factor of safety on the critical slip surface for cross section D-D' under March 21, 2005 groundwater levels is about 1.2, compared to a factor of safety of 2.7 for a slip surface that is forced to pass deeper into the slope and intersect the house at 2205 Berkley.

Based on these guidelines and the results of the slope stability analyses reported in Table 1, BGC recommends that the residence at 2205 Berkley may be occupied on a permanent basis, provided ongoing monitoring and water management conditions are met, as outlined below.

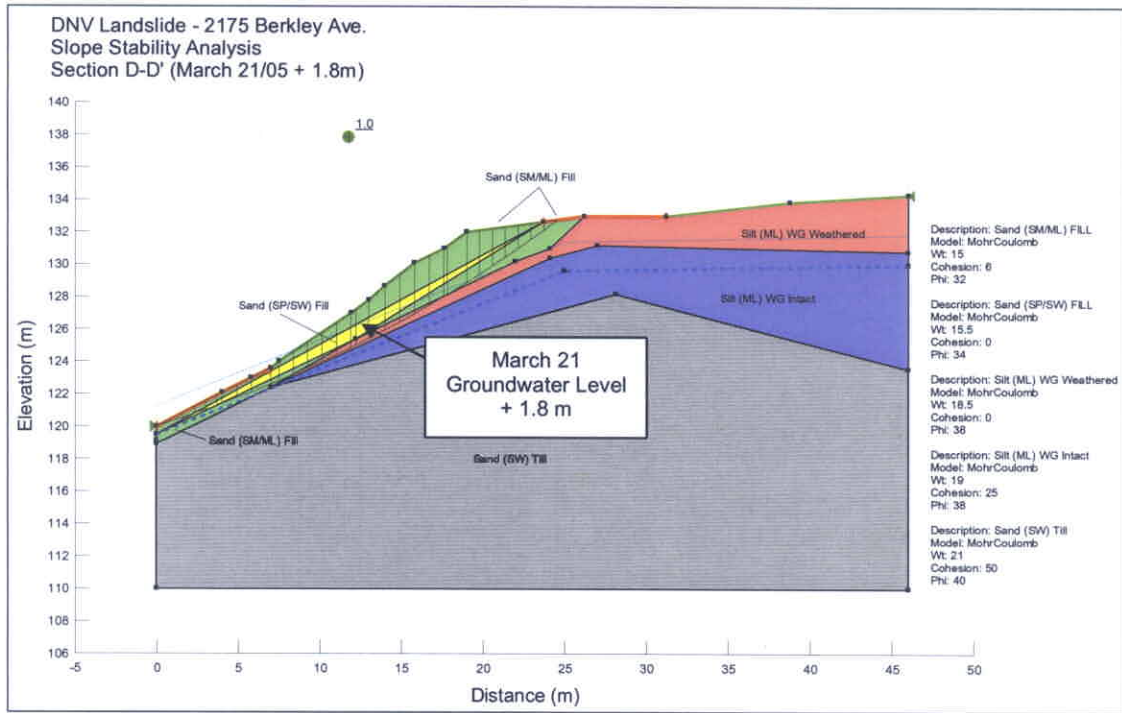
Figure 2. Slope Stability Analysis for Slides Impacting the Back Yard at 2205 Berkley

Additional slope stability modelling was undertaken to determine the water levels that would likely trigger a landslide in the back yard of 2205. The analyses suggest water levels would have to be about 1.8 m higher than measured on March 21, 2005 (Figure 2). The resulting landslide could extend up to 6 m east into the back yard of the property, and could have an initial volume of between 250 and 500 m³. Detailed runout modelling for this hypothetical landslide has not been carried out, but depending on the direction the slide travels it appears that the debris could reach some of the properties at the base of the escarpment, including 2290, 2296, 2430 and 2440 Chapman Way, and 2318 and 2336 Treetop Lane. Not all of the

properties would be impacted by a single landslide, nor would structural damage be anticipated on all properties. 2318 and 2336 Treetop Lane appear most likely to be impacted and most likely to sustain structural damage, should another landslide initiate from the back yard of 2205 Berkley Avenue.

While the house at 2205 Berkley is not expected to be impacted by a landslide, the back yard of the residence and properties located below the lot could be. Risks from such a landslide can be reduced through piezometer and rainfall monitoring, slope inspection, and control of surface runoff as described above, or through physical slope remediation such as the installation of retaining walls.
