Golder Associates

REPORT TO
THE DISTRICT OF NORTH VANCOUVER
ON
MUDSLIDES - DECEMBER 17th, 1979
RIVERSIDE DRIVE
NORTH VANCOUVER, BRITISH COLUMBIA

January, 1980

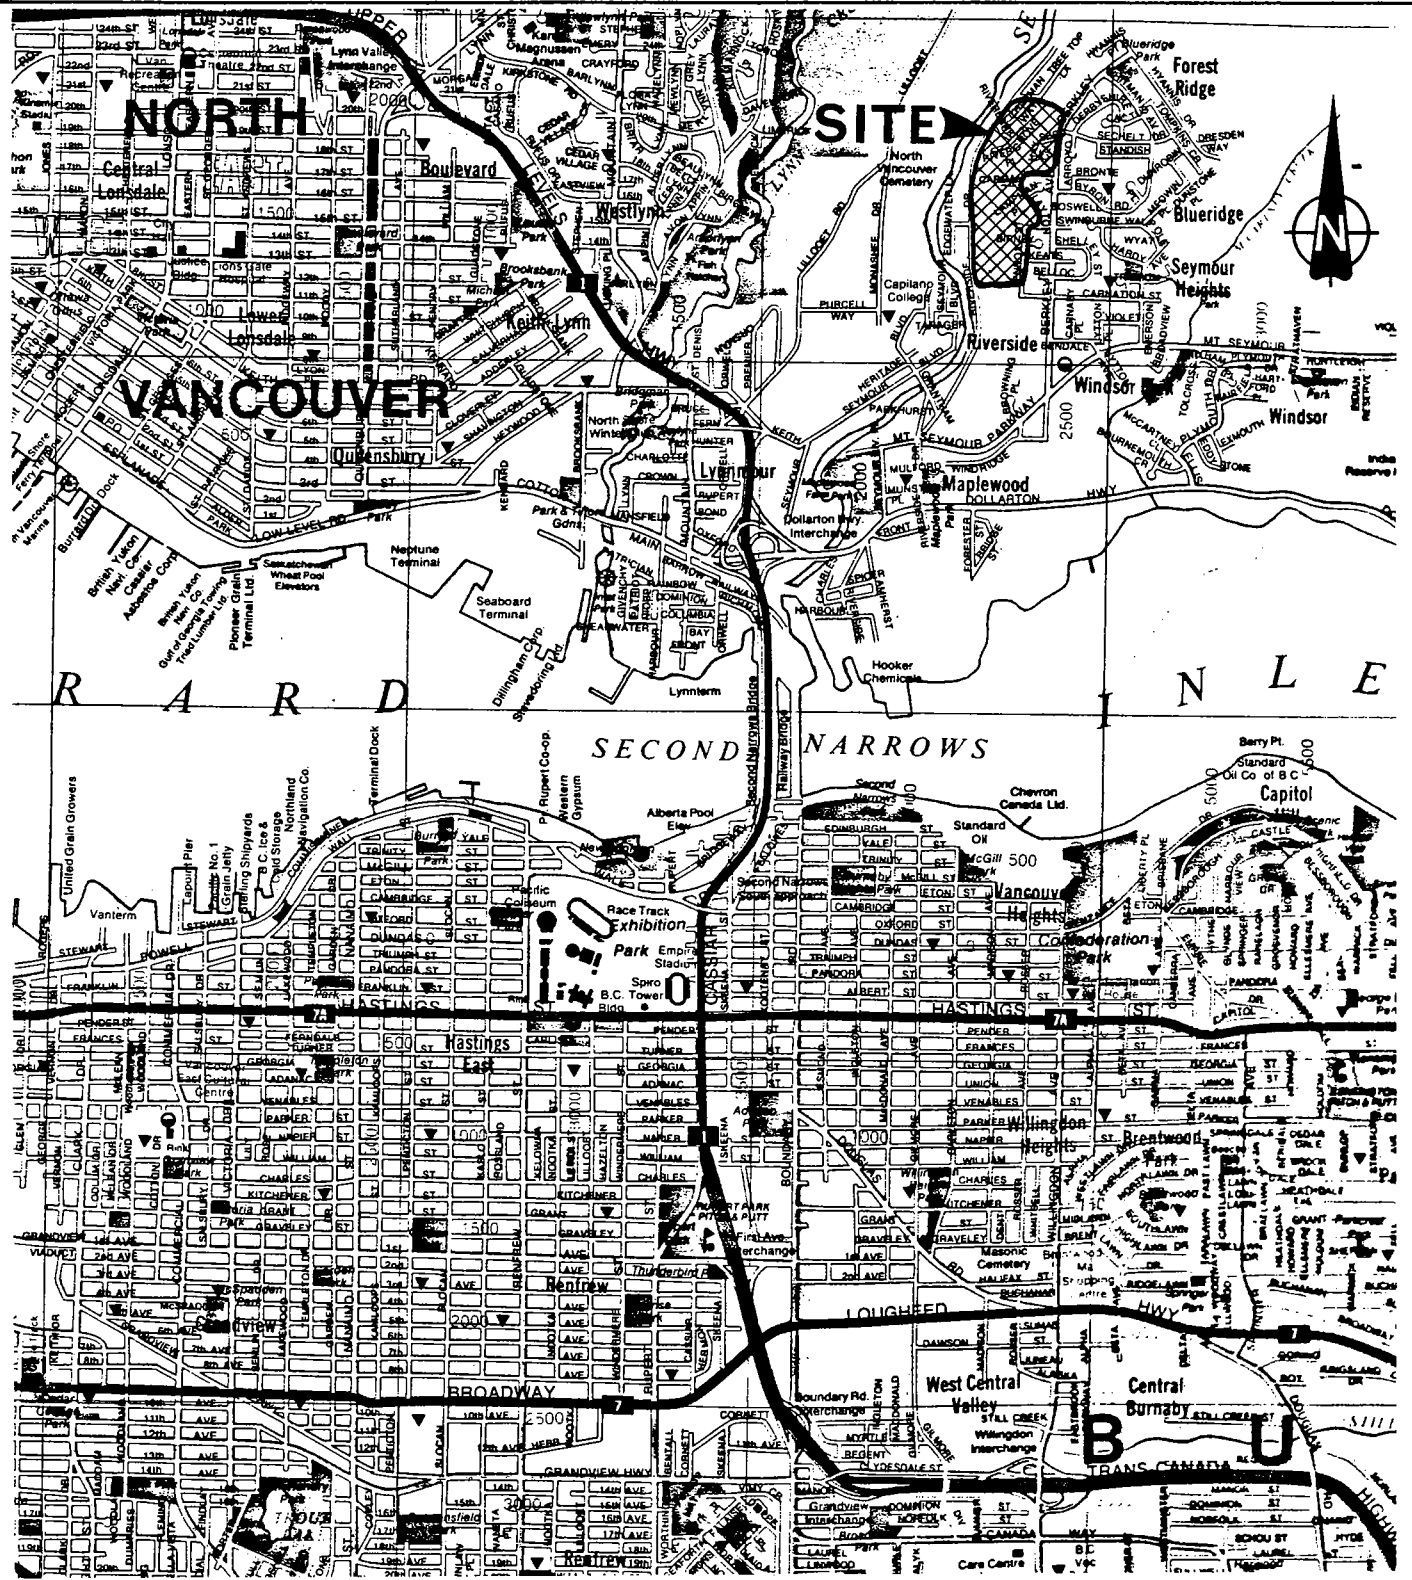
Figure 1

KEY PLAN

On December 17th, 1979, three surface slides occurred on the steep slope between Berkely Road and Riverside Drive on the east side of the Seymour River at the locations shown on Figures 1 and 2. The slides took place following a 24 hour period of extremely heavy rainfall and a 5 day period of very heavy rainfall. Precipitation during the 24 hour interval immediately preceding the occurrence of the slides exceeded the previous 1972 record rainfall by approximately 13 per cent.
